# Assessment of the Physical Characteristics of Individual Household Rainwater Tank Systems in South East Queensland

October 2012

Urban Water Security Research Alliance  
Technical Report No. 66

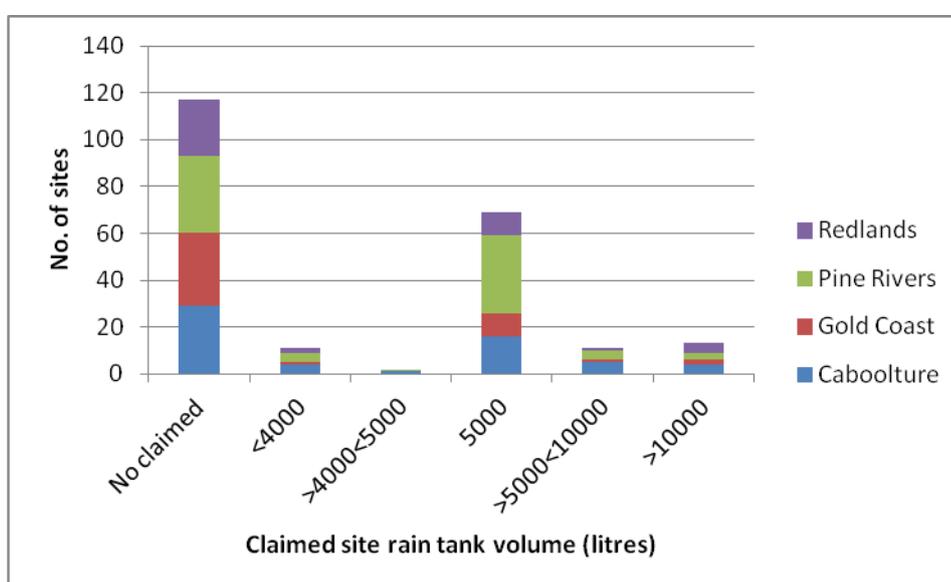
**Figure 2: Distribution of rainwater tank size from manufacturer's data for the four LGAs.**

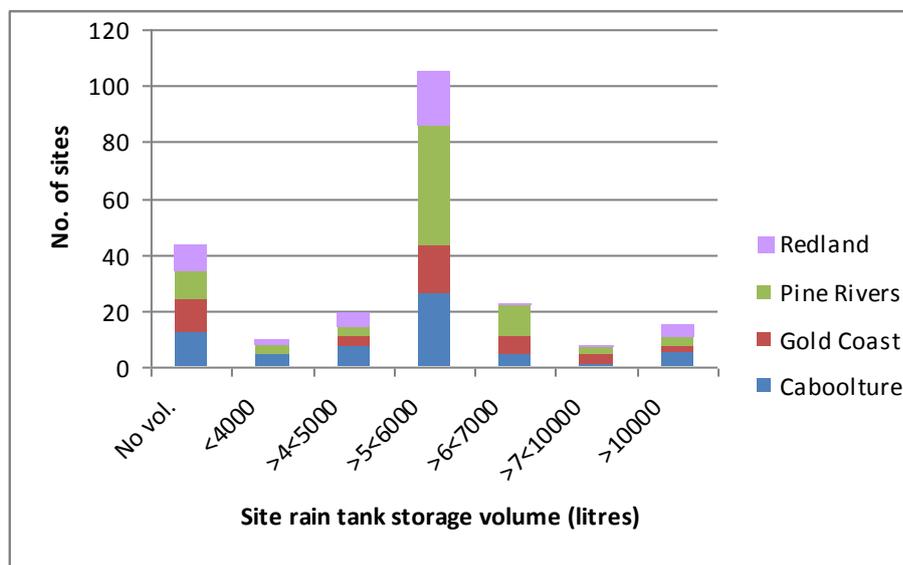
Over the four LGAs, 84% of sites with calculated storage volume were at or above the MP 4.2 minimum compliance volume of 5,000 L (Table 5), with most sites (58%) in the 5,000 L to 6,000 L class and 13% in the 6,000 L to 7,000 L class (Figure 3). Around 16% of sites had storage volumes that were less than the required 5,000 L. When sites which are within a 20% variance of the minimum volume were included, 94% of sites were at or near the minimum compliance level. However, even allowing for a 20% variance, there were only 10 sites (0.5%) which were below the minimum compliance level. Caboolture had the lowest level of compliance at 91% with Gold Coast the highest at 100% compliance. Allowing for the 12% over-estimation in calculated storage volume, compliance in all LGAs was well above the required 5,000 L specified in MP 4.2.

**Figure 3: Distribution of measured rainwater tank storage volumes (litres).**

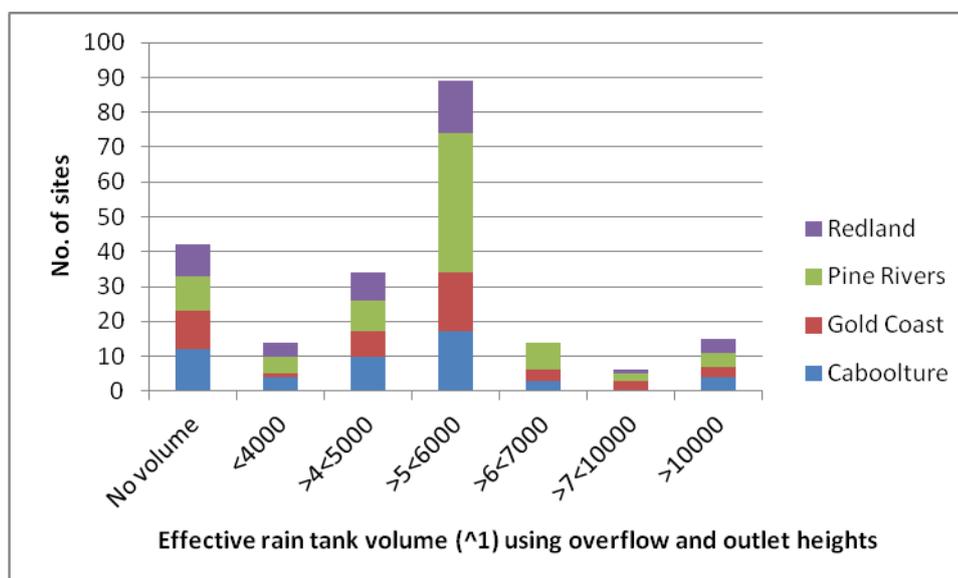
Figure 4 shows the distribution of effective tank volumes excluding the dead tank storage area above the overflow and below the pump outlet (effective volume ^1) across the four LGA.

**Figure 4: Distribution of site rainwater tank effective volume ^1 (litres) using heights from pump outlet to tank overflow.**

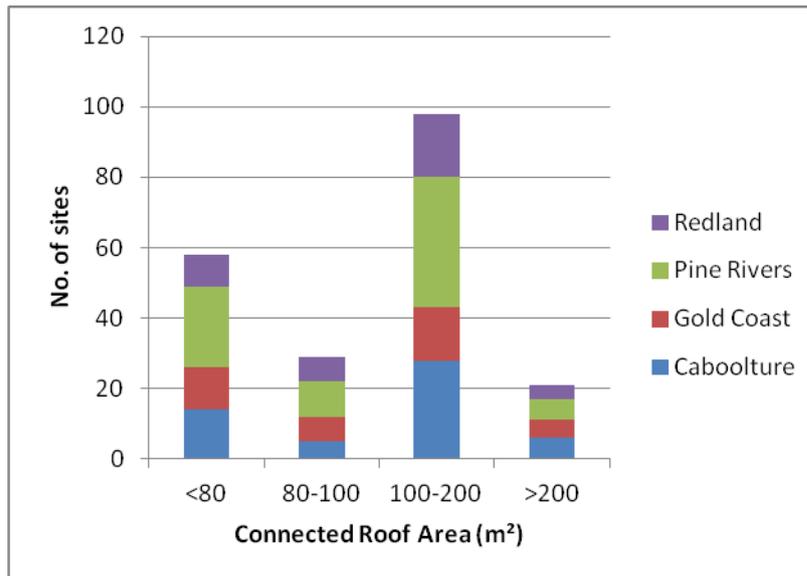
Figures 5 and 6 illustrate in bar chart format the data from Table 10 of connected roof area and percentage of total roof area connected to the rainwater tanks, respectively, for each of the four LGAs. For example in Pine Rivers, 23 houses (30%) had <80 m<sup>2</sup> connected roof area and 42 houses (55%) had <40% roof area connected to the rainwater tank.

Figure 5: Connected roof area (m<sup>2</sup>) for the four LGAs.

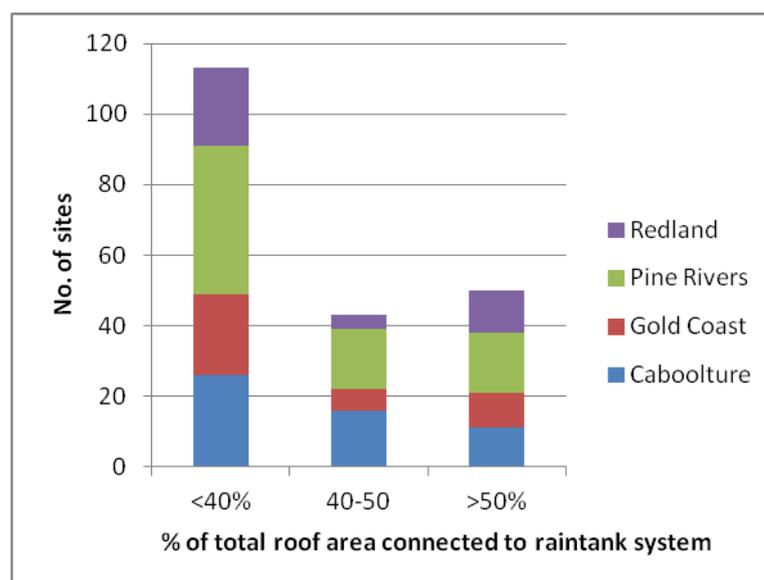
Figure 6: Percentage of total roof area connected to rainwater tanks for the four LGAs.

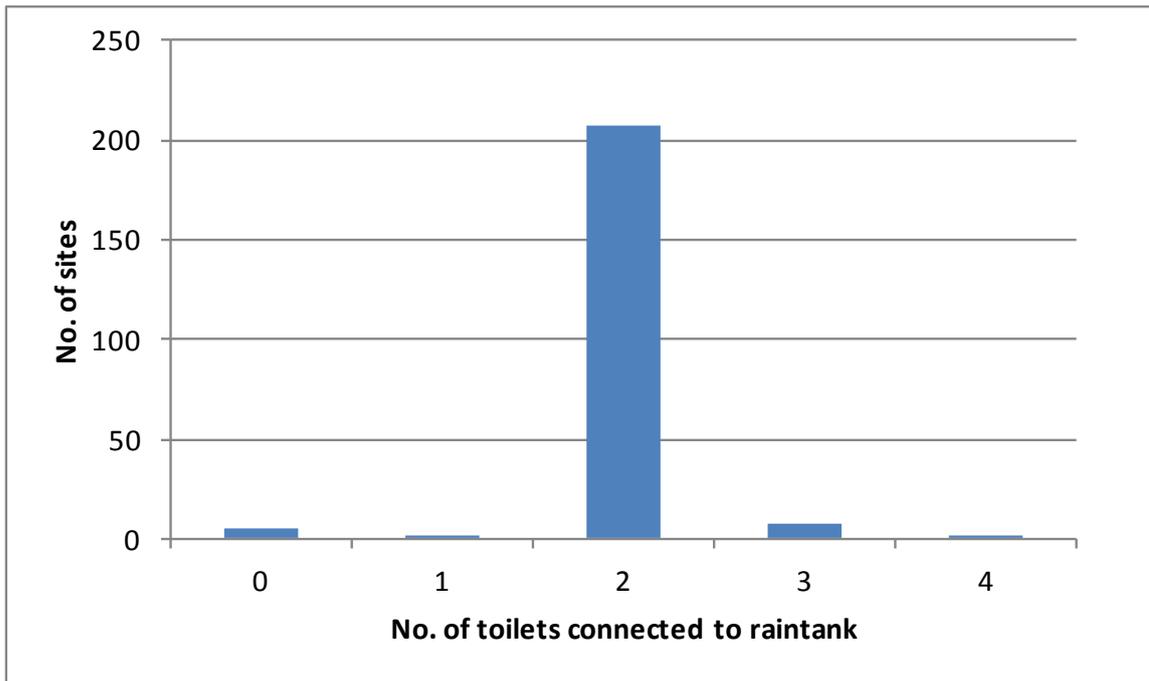
**Figure 7: Number of toilets connected to the rainwater tank system.**

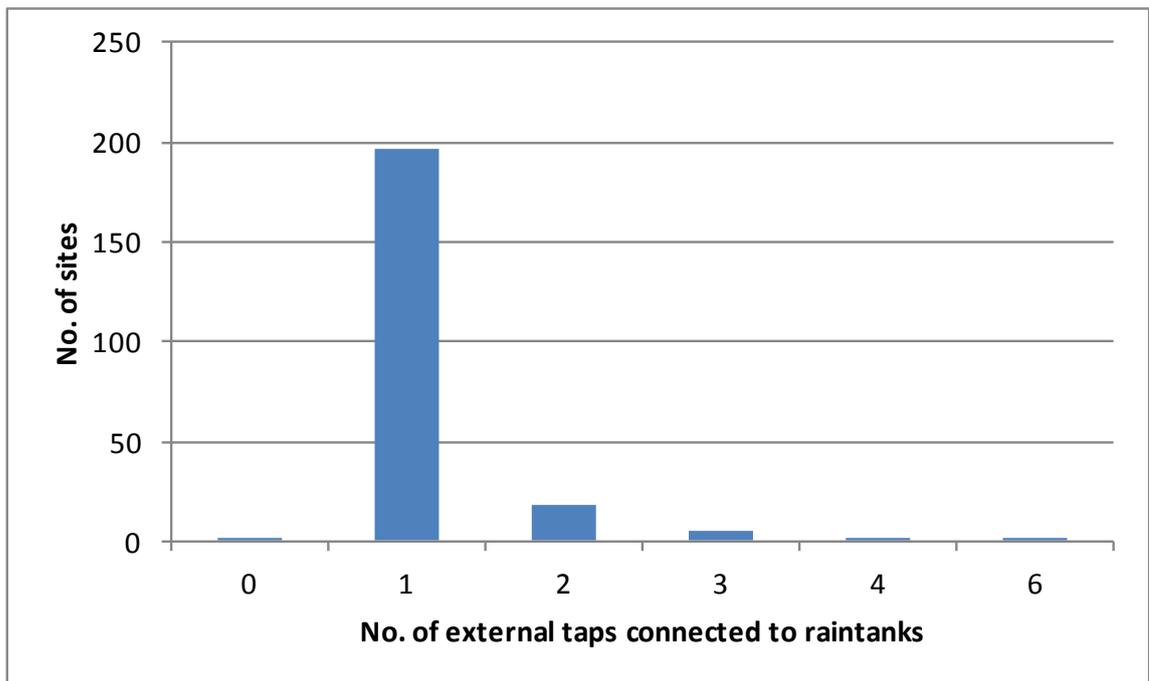
The more household appliances that are plumbed or connected to rainwater tank, the more rapidly the water level in rainwater tanks will be drawn down, resulting in a higher rainwater use and greater mains water savings. MP 4.2 (A2(c)) requires that rainwater tanks be connected to: (1) toilet cisterns and washing machine cold water taps (other than those connected to a greywater treatment plant or alternative water substitution measure); and (2) an external use. Most of the sites inspected were fully compliant with regard to required connection to household appliances and to an external tap. All homes inspected had one washing machine present and only 2% of households (five sites in Caboolture) did not have their washing machine connected to the rainwater system. 93% of sites had two toilets connected to the rainwater tank with only five sites not having any toilet connected at all (Figure 7). Except for one site, all homes inspected had at least one external tap connected to the rainwater tank system (Figure 8).

**Figure 8: Number of external taps connected to the rainwater tank system.**
